URGENT SAFETY ADVICE

| 1. INCIDENT DESCRIPTION | | | |
|---|--|---|---|
| INCIDENT NAME | Derailment at Washwood Heath West | | |

| 2. URGENT SAFETY ADVICE | |
|---|---|
| TITLE: | The control of risks associated with worn centre pivot liners on freight vehicle bogies. |

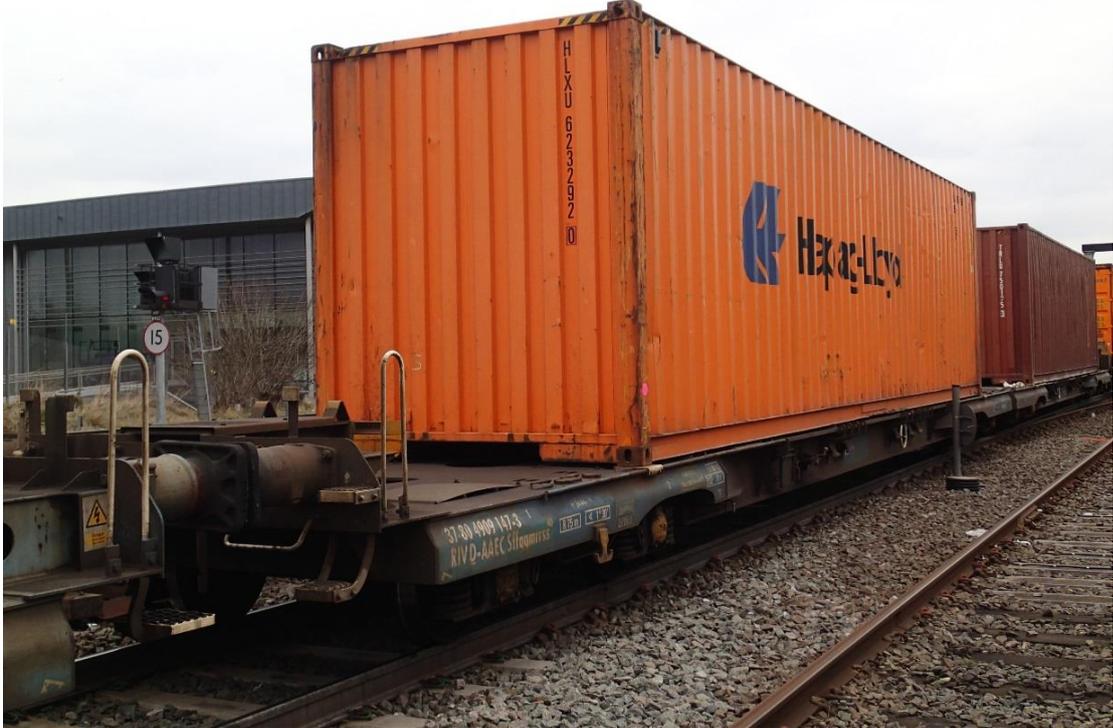
| 1. INCIDENT DESCRIPTION | | | |
|---|--|---|---|
| SUPPORTING REFERENCES | <p>Figure 1: The wagon involved.</p> | | |

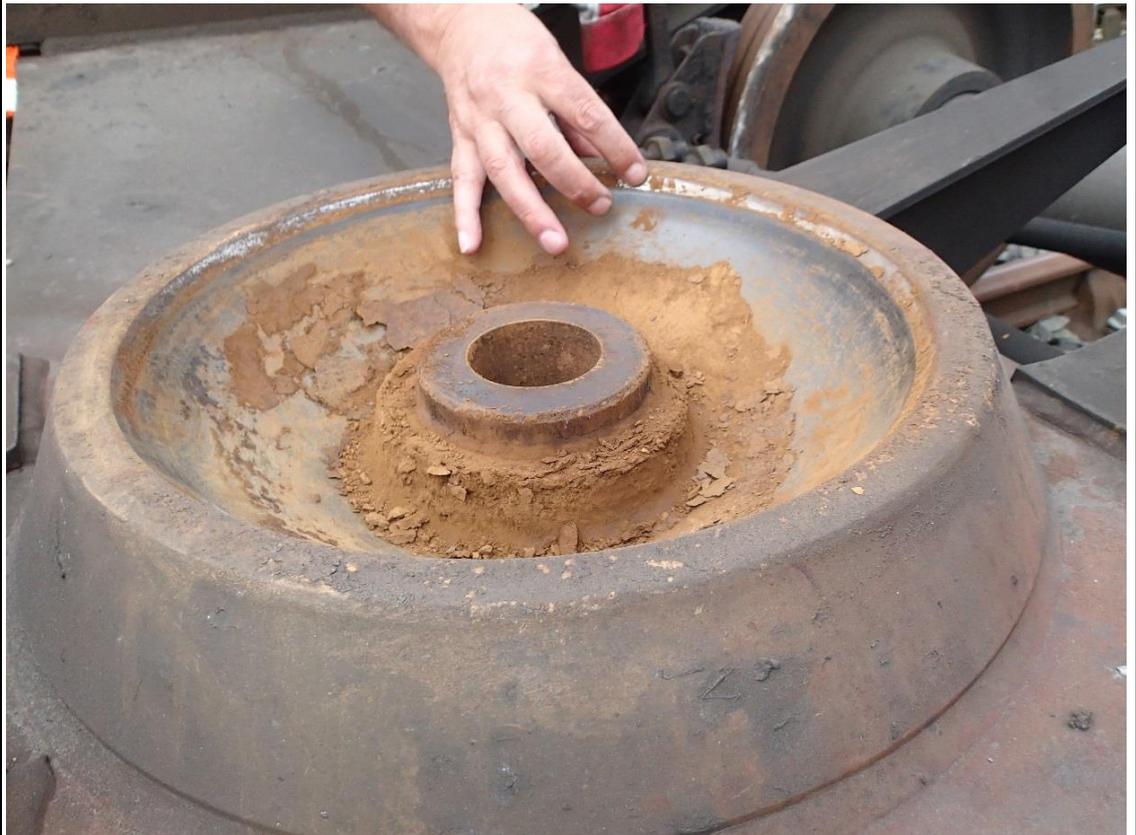
Figure 2: Centre pivot liner worn below level of steel rim, leading to contact between steel surfaces

| 2. URGENT SAFETY ADVICE | |
|---|---|
| CIRCUMSTANCES: | <p>The wagon involved in the derailment was tested for wheel unloading, in accordance with Railway Group Standard GM/RT2141, and the amount of wheel unloading significantly exceeded the permitted 60%. This would have increased the likelihood of derailing on track which was twisted. The track at the site contained a twist with a magnitude that, according to Network Rail's standard NR/L2/TRK/001, fell within the band for which the remedial action was 'Correct within 36 hours'.</p> <p>When lifted from its bogies to examine the wagon further, it was found that the plastic centre pivot liners had worn to such an extent that the steel centre pivots on the wagon body were in direct contact with the steel bowl attached to the bogie (figure 2). This would have led to high friction between the surfaces, compared to the intended level of friction between the steel pivot and the plastic liner. The increased friction reduces the ability of the bogies to rotate.</p> <p>The worn centre pivot liner also led to a reduction in the clearance between the side bearers and their end stops (figure 3). This increased the amount of unloading of vertical load on the wheels as the wagon traversed cant transitions and twisted track.</p> <p>The combination of reduced load on the wheels on one side, combined with the increased resistance of the bogies to rotate, led to the wagon derailing by flange climbing as it negotiated a reverse curve with a track twist.</p> |

| 2. URGENT SAFETY ADVICE | |
|---|---|
| SAFETY ADVICE: | <p>The life of centre pivot liners will be dependent on the material that they are made from. Where the maintenance plan for a vehicle has been devised on the basis of using a particular type of centre pivot liner with a known rate of wear, Entities in Charge of Maintenance (ECMs) should ensure that the specified liner, or one with the same (or better) rate of wear, is always fitted (regardless of whether the maintenance is done by their own staff or by contractors).</p> <p>The liner should not be substituted for one with different wear characteristics unless the ECM has previously revised the maintenance plan to take account of the new liner. Where the wear characteristics of a new liner are unknown, steps should be taken to understand them before installation.</p> <p>When it is decided to install a new liner with characteristics different to those specified, the adequacy of the existing maintenance regime should be assessed. In particular, the intervals between liner inspection and replacement should be set such that the regular maintenance activities ensure that the liner is replaced before it has worn to such an extent that it adversely affects the ability of the bogie to rotate or reduces the sidebearer clearance beyond its limit.</p> |

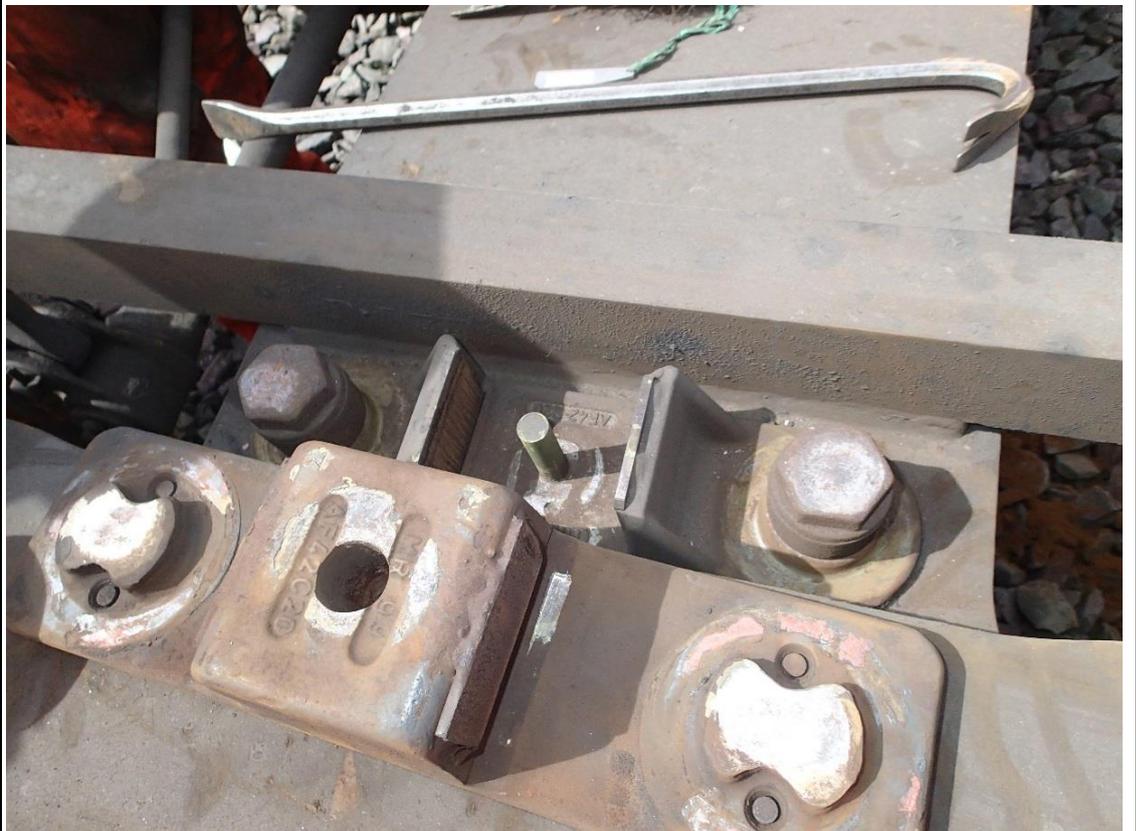
Figure 3: Sidebearer showing signs of frequent contact with end stops
