Bulletin of General Information
Derailment of a Lineas freight train
Aubange - 19th May 2017

Derailment of a freight train on regular track.

Line 165, in Aubange

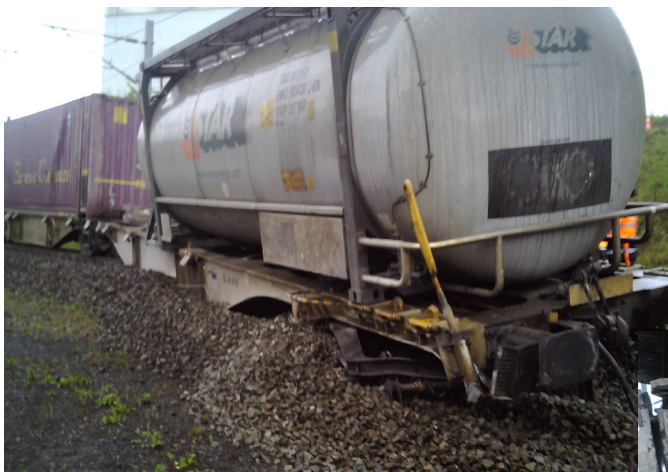
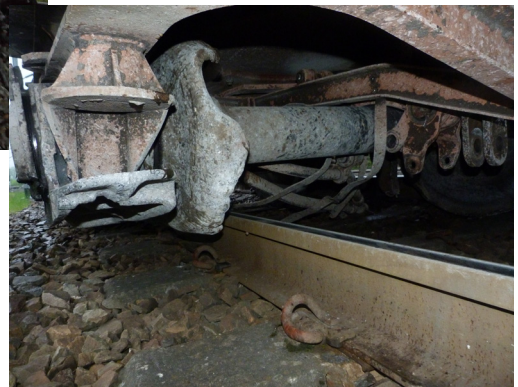
Derailed wagon : Type Sggmrs - Vehicule n° 3368495200729

Important damages to the 2 last wagons (not laying down on its flank)

Wheel fracture of the wagon n° 3368495200729

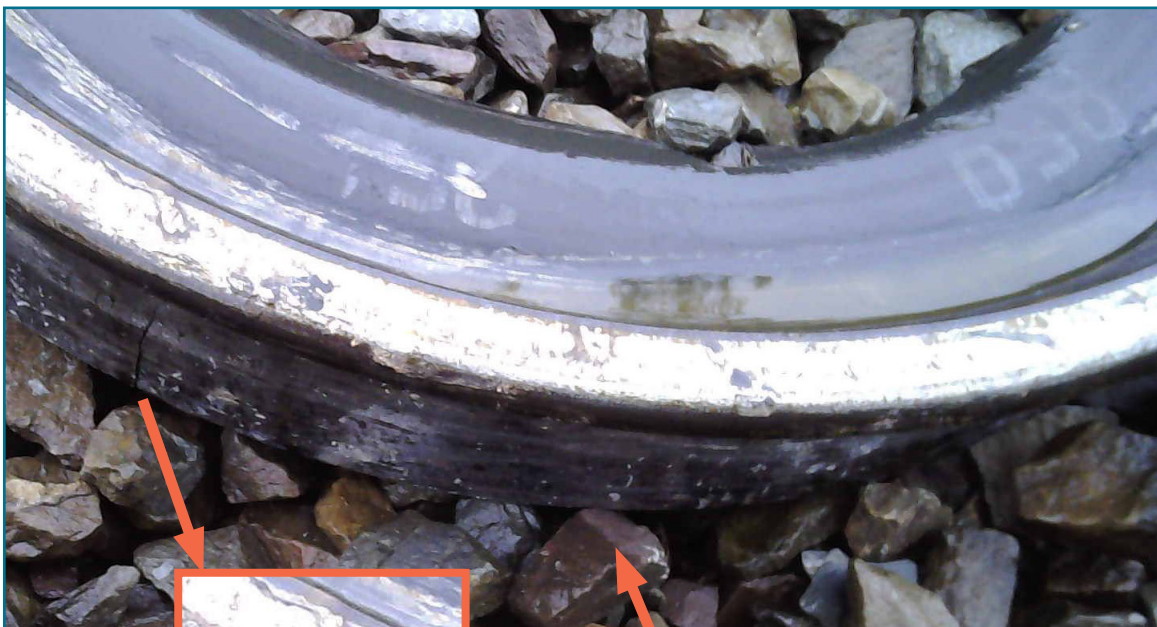
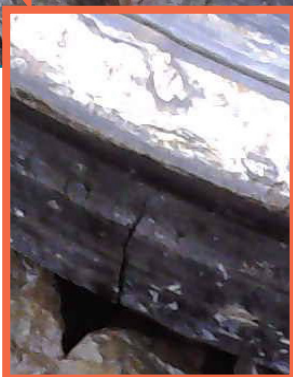
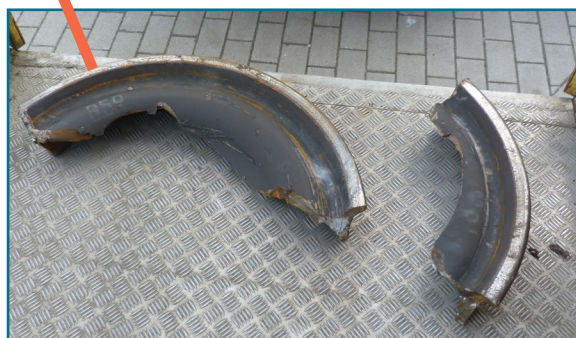
The wheelset with the number 028 104.

This wheelset 028 104 had the last big overhaul (IS 2) in EM Kaiserslautern at 29.10.2015

Diameter of the broken wheel in 2015 : 859 mm

Reprofiling performed in 2015 from 868.2 to 859.4 mm

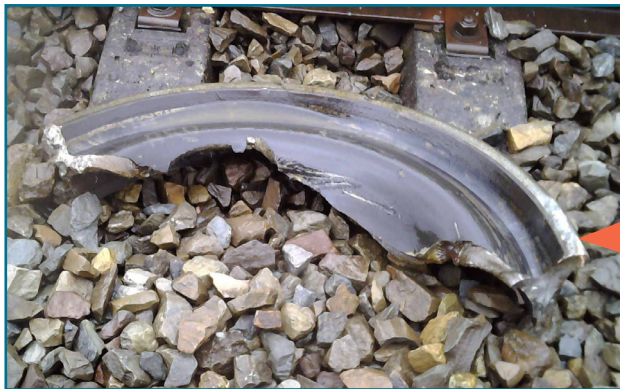
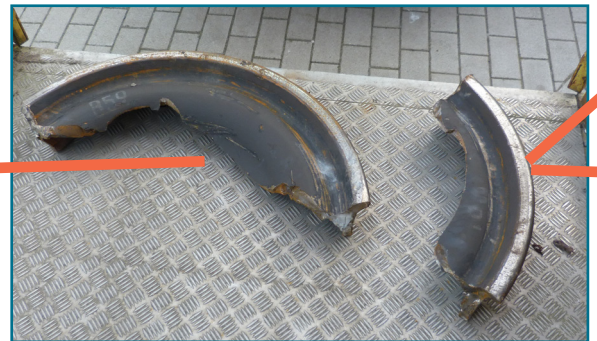
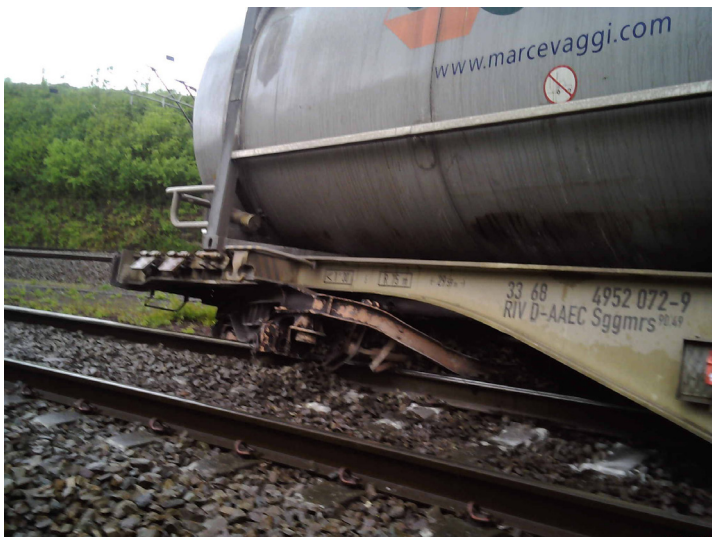
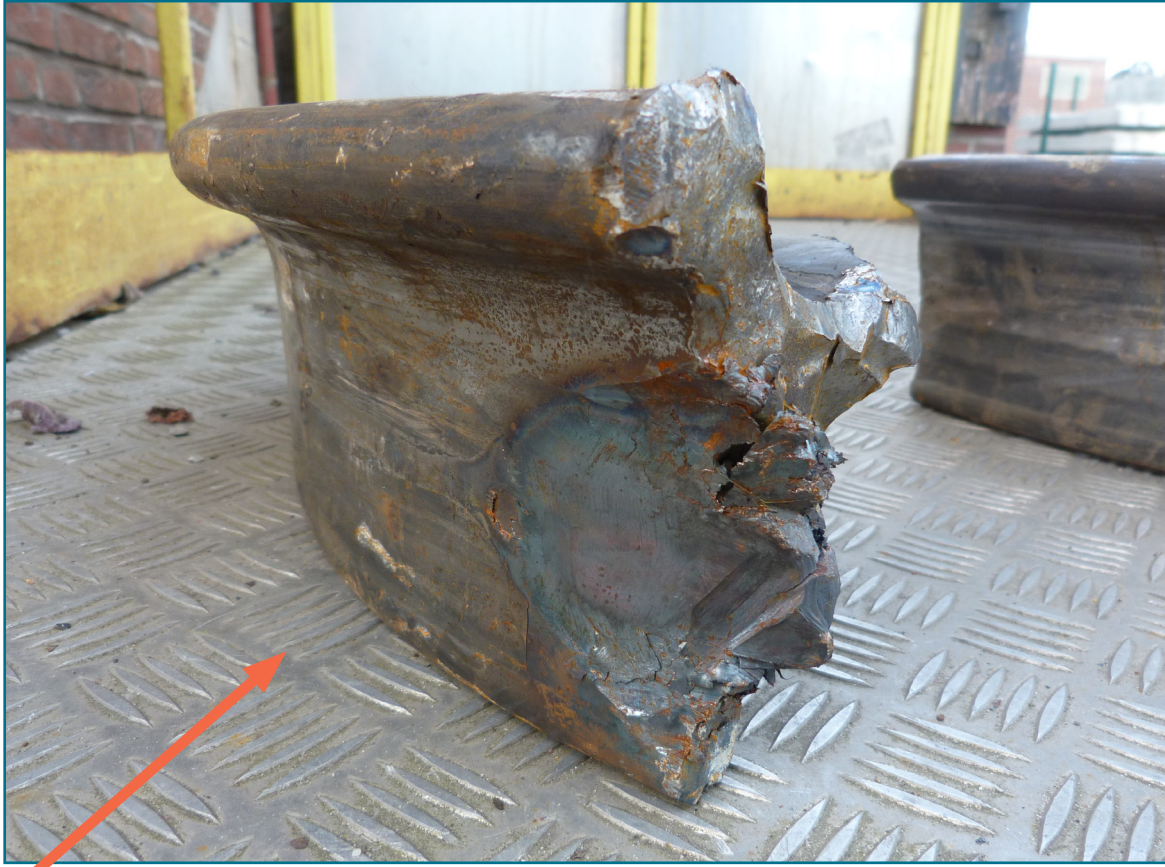
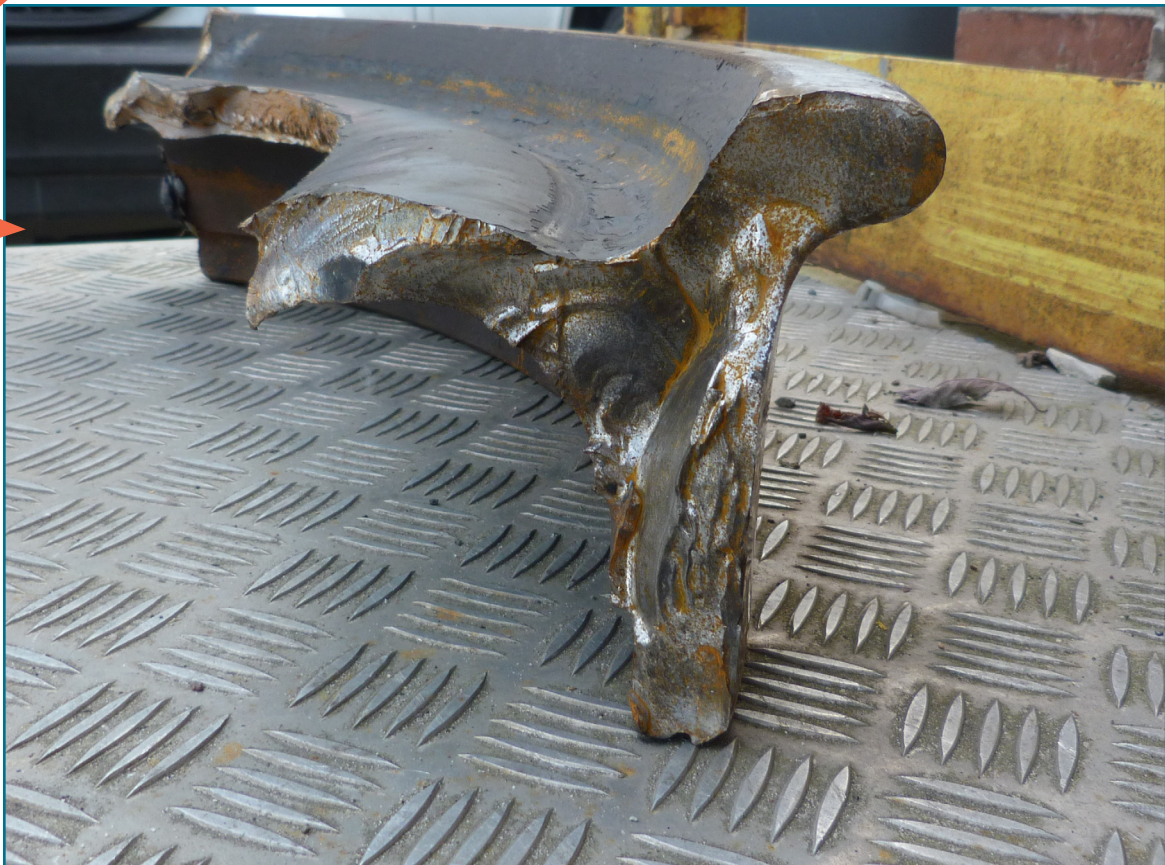
After several kilometers, the right wheel of the second bogie of the vehicle n° 3368495200729 breaks (before last wagon).

The train continues its trajectory on a distance of ± 14 kilometers till Aubange where the two last wagons (of same type) derail on switches, after damages the track on this distance.

According to first elements in our possession, the derailment has most probably been caused by the fracture of the wheel.

Two pieces of the broken wheel were found back during the on-site investigation : these pieces are transferred to a laboratory to perform several tests and analyses.
