Rail Accident Report

Freight train derailment at Ely West Junction 14 August 2017

Report 09/2018
August 2018

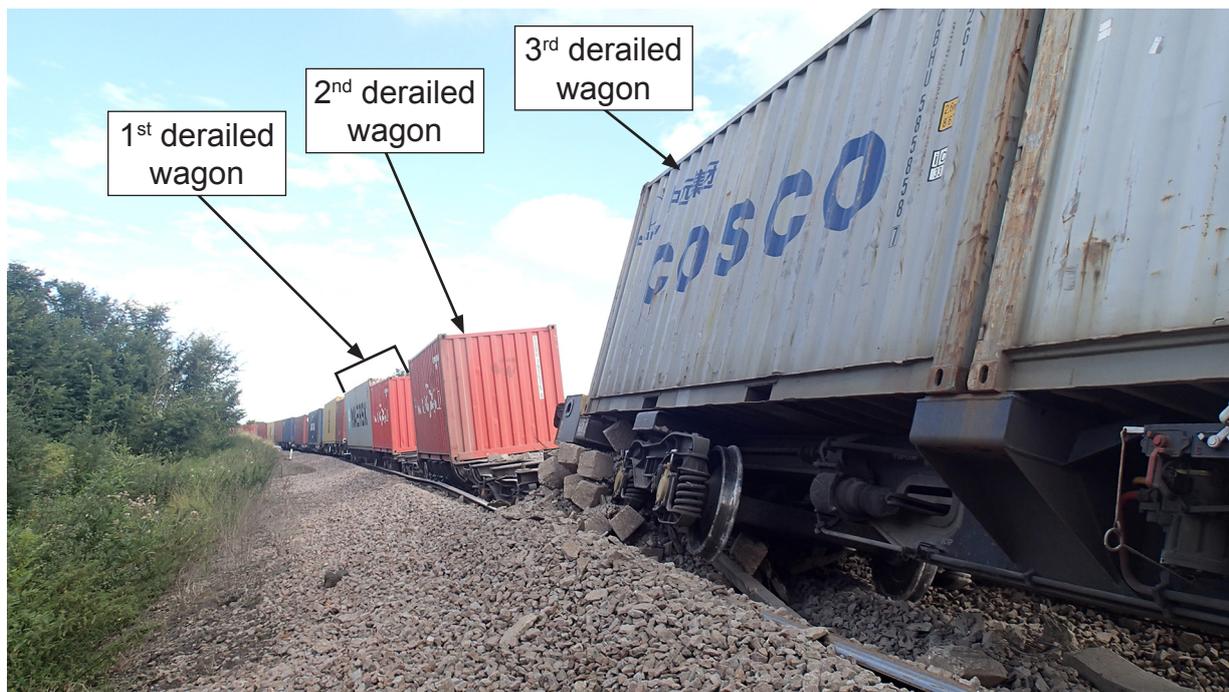
Figure 2: Derailed wagons on site

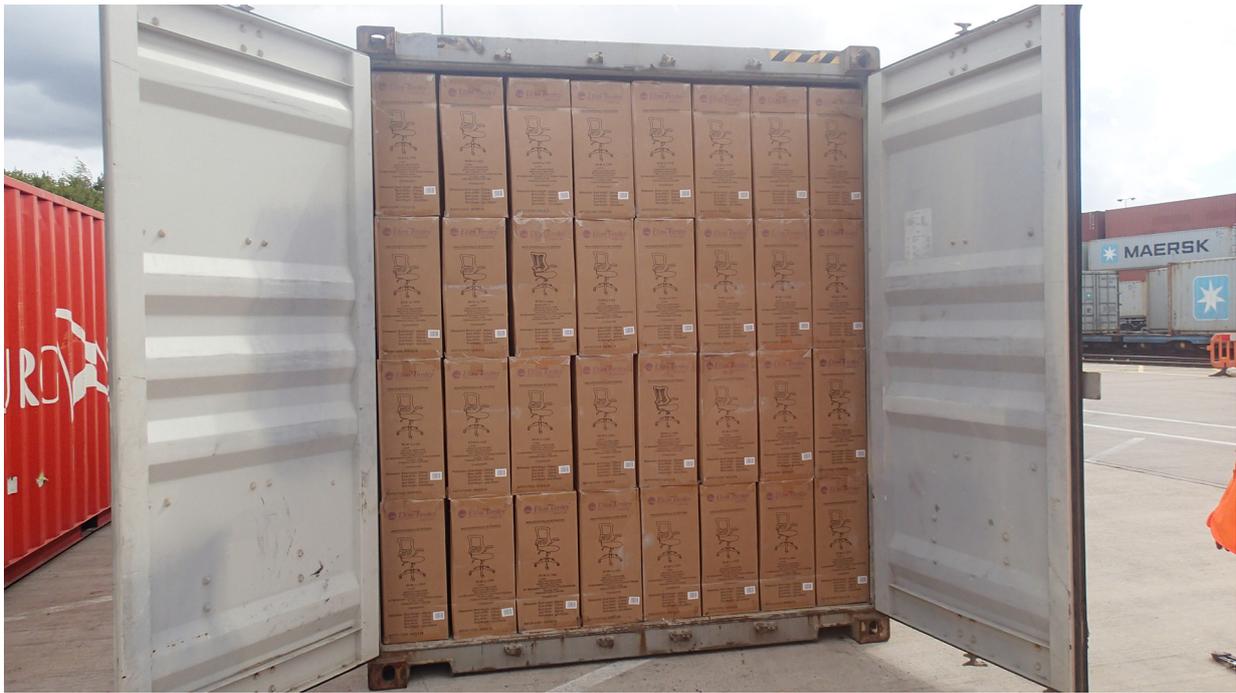
- 11 Wagon 630034 carried a 40 foot container in the leading position and a 20 foot container in the trailing position. Examination of these containers after the accident showed that the 40 foot container was packed with office furniture (figure 4) and the 20 foot container with pallets of floor tiles (figure 5). The mass of the 40 foot container was measured as 11.2 t and the 20 foot as 27.6 t. The payload in the 20 foot container was such that the centre of gravity of this container was offset both longitudinally and laterally. Photographic evidence showing the content of the container as it was packed in Izmir (Turkey) before coming to the UK demonstrated that the payload had moved marginally longitudinally and laterally, likely as a result of the derailment, between packing and post-accident inspection. The load position as recorded in Izmir was used during the investigation.

Figure 4: 40 foot container opened post-accident

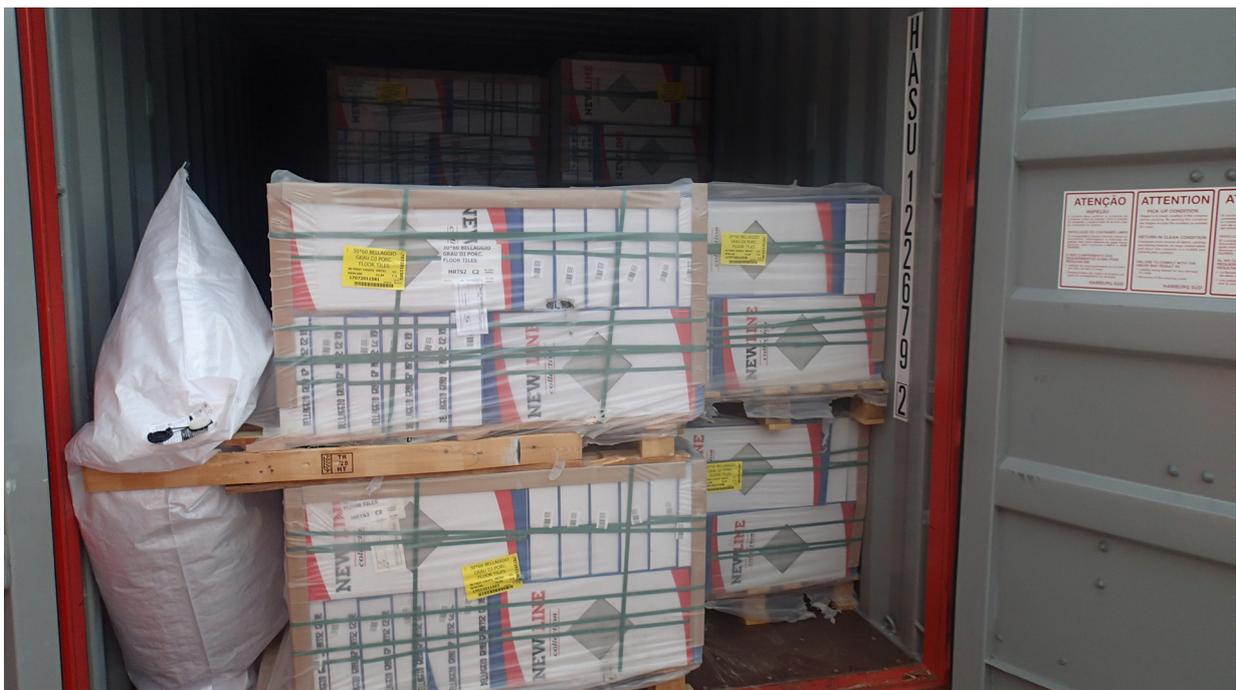
Figure 5: 20 foot container opened post-accident

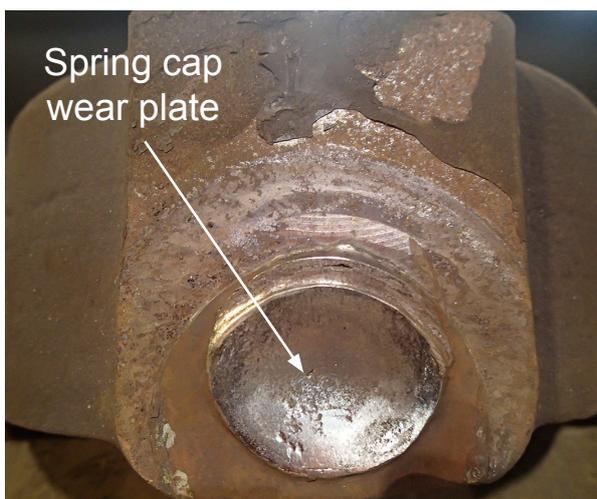
- 32 Wagon 630034 was examined at March depot after the derailment. The wagon underframe was lifted which enabled the bogies and their components to be examined. Of particular note was an unusual wear pattern on the spring cap wear plates (figure 9). This wear pattern suggested that:
- the spring cap wear plate had been sitting higher than the bush (figure 10); and
 - the spring cap wear plate had been pushing against the top of the bush instead of the plunger which suggests that the plunger was recessed inside the bush, instead of passing through and protruding from it (as shown on figure 11).

Figure 9: Wear pattern on incident spring cap wear plate

- 69 The RAIB ascertained the relative vertical position of the bush and spring cap wear plate centrelines using the dimensions contained in the VPI maintenance guidelines and standard bogie components drawings. As new, the centreline of the spring cap wear plate (diameter 36 mm) is aligned with the centreline of the bush (diameter 55 mm). As the damping components including the Lenoir links and trunnions wear, the spring cap moves up in relation to the bush position. The RAIB calculated that at the extreme of wear of the components¹⁵, the top of the spring cap wear plate may sit higher than the top of the bush. The physical evidence showed this was 4 mm in the incident axlebox (figure 9).

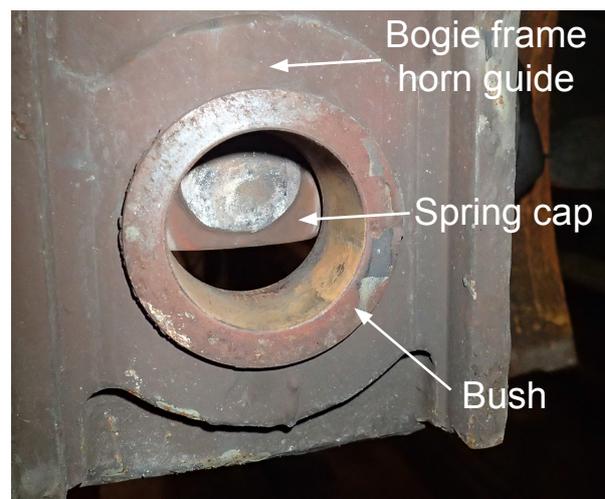
Figure 10: Position of spring cap wear plate relative to bush reconstructed on trailing axle of incident wagon (for illustrative purposes only)

33 The fact that the spring cap wear plate was sitting higher than the bush is demonstrated by the physical evidence. In order to establish whether the plunger had been sat recessed inside the bush, the RAIB took detailed measurements of the leading right-hand axlebox, the one associated with the wheel which first derailed, and its plunger. This enabled a comparison of the stacked length of these components with the measured distance between the bush and the horn guide wear plate. Table 1 shows the results.

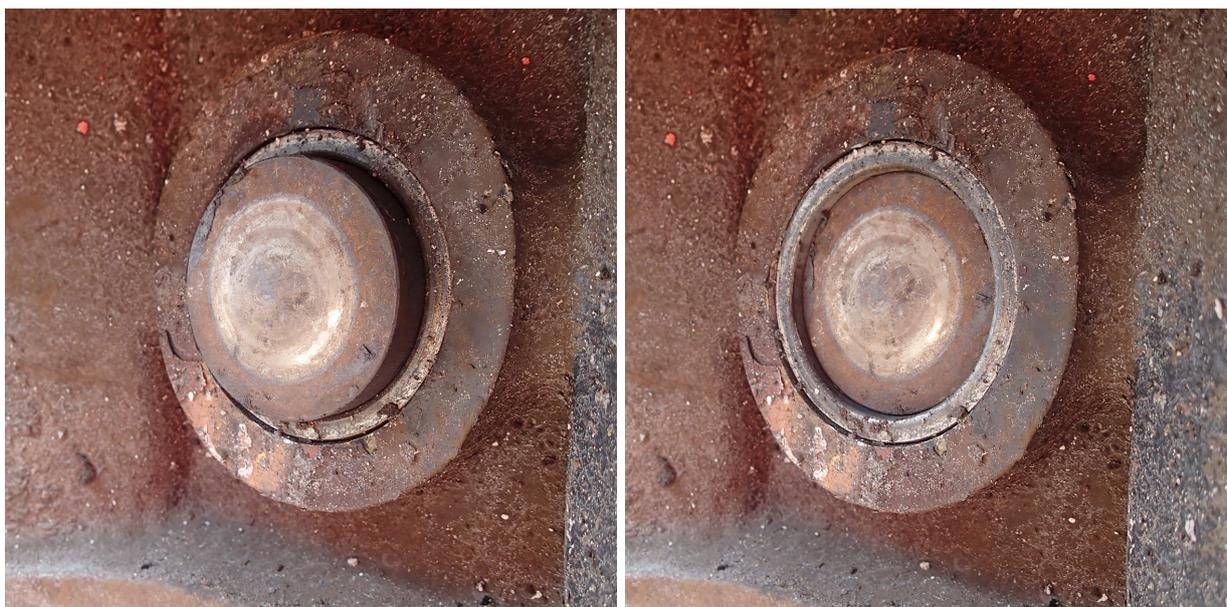
Figure 11: A plunger in normal position and in a recessed position - reconstructed on a different wagon for illustrative purposes

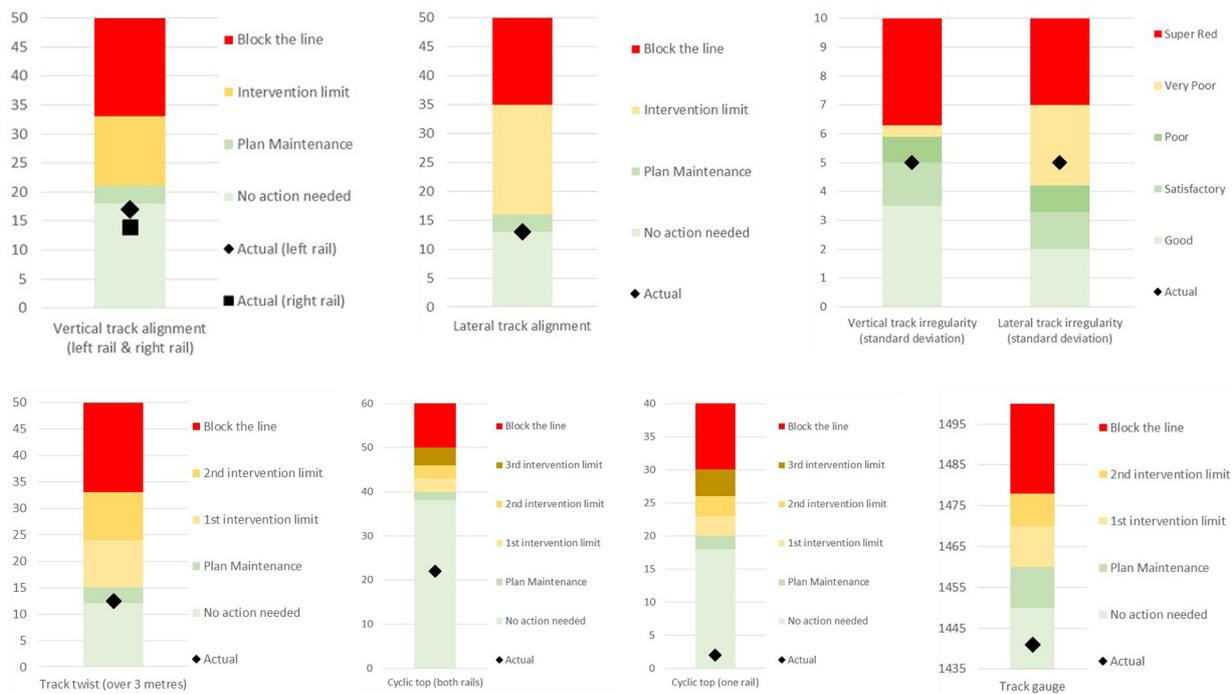
- 51 A 'poor' rating does not trigger any required action by Network Rail whereas a 'very poor' rating requires the people in charge of track maintenance to review what might be driving this rating and, where necessary, to take corrective actions. As such, the level of lateral irregularity was included in the sensitivity study. All other track factors were found to be within alert limits and hence were not included in the study. Figure 13 shows the input parameters and compares their values against the limits.

Figure 13: Track input parameters

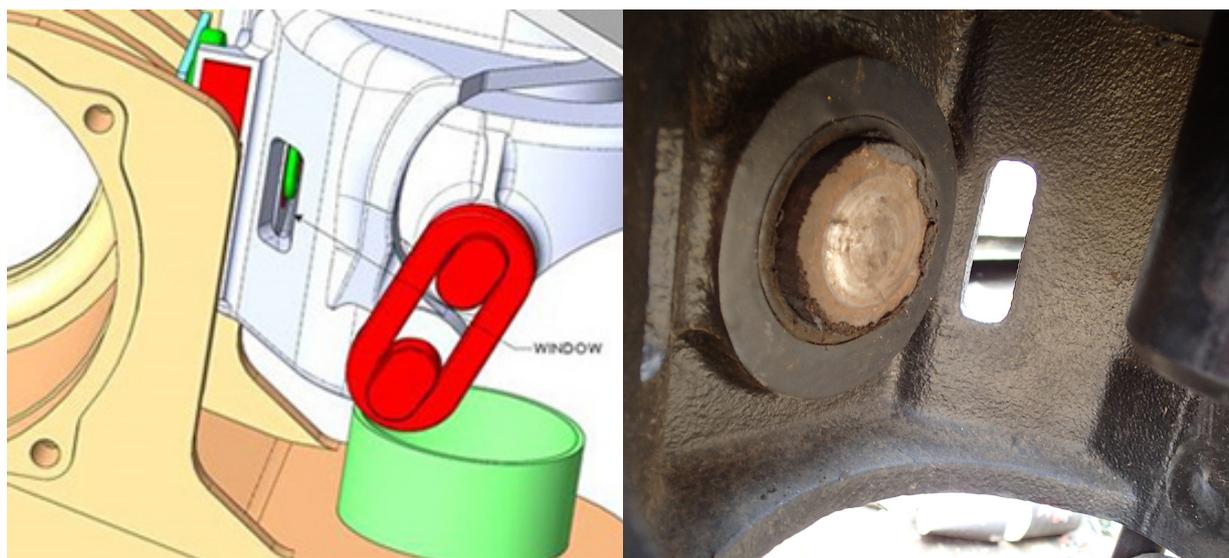
76 Some bogies of the Y-series family are equipped with a window allowing visibility of the plunger and the spring cap (figure 14). The origin of this window could not be traced, but its purpose is almost certainly to provide a means to inspect the position of the spring cap wear plate relative to the plunger and bush (paragraph 61).

Figure 14: Inspection window on Y-series bogies (outside and inside view)

77 The bogies fitted to the FEA-A wagons are not provided with this inspection window. However, other Y-series bogies operated and maintained by GBRf, but supplied by different manufacturers, are equipped with the window. A review of the associated maintenance documentation shows that GBRf does not make use of the windows. It is therefore unlikely that it would have made any difference had a window been provided on the Techni-Industrie bogies.
