# Safety incidents on ETCS Level 2 lines in Switzerland on April 16th and June 27th 2019

File reference: BAV-503.233-2/1/1

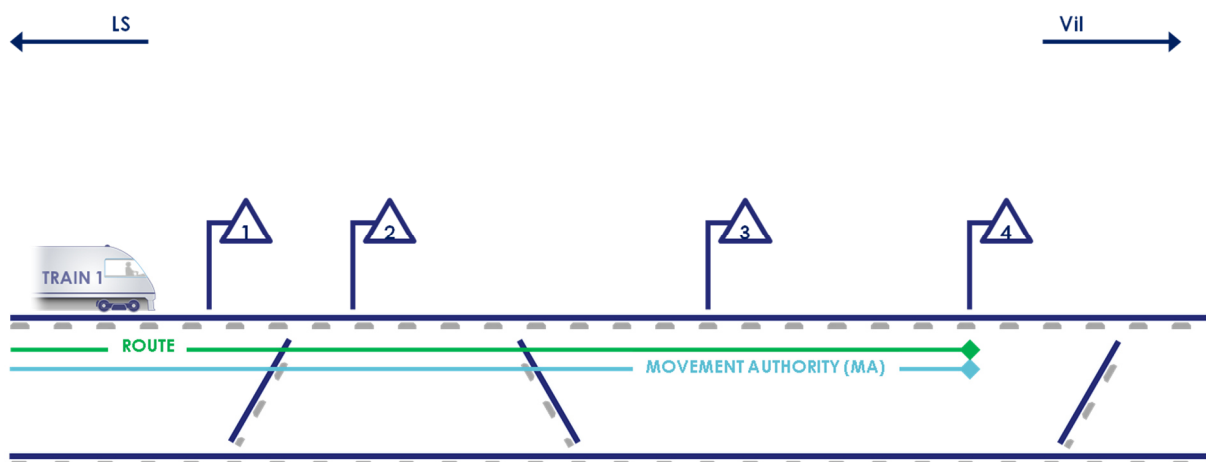
Figure 1

- Train 1 runs from LS to VII. (set route is indicated in green, MA is indicated in blue)
- All signals have release speed (Figure 1)
- Train 1 shows a large confidence interval (indicated in red) (Figure 2)
- Section between Signal 2 and 3 is occupied by train 1, min SFE remains in front of Signal 2 (Figure 2/3)

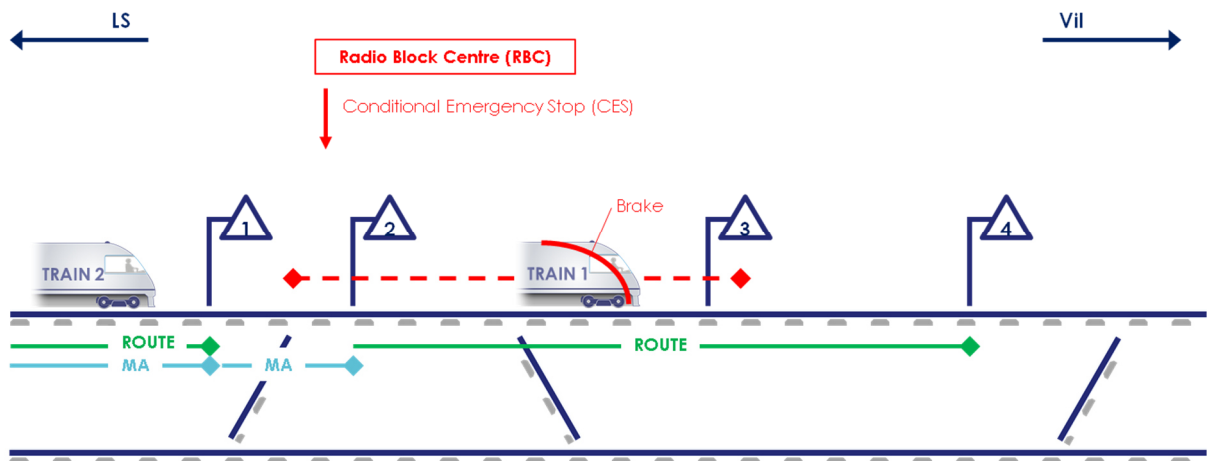
Figure 3

- Due to the function “signal stop evaluation” (1), a new MA of train 1 is sent with EoA at signal 2 (Figure 3)
- Train 1 proceeds (with RS), min SFE remains in front of signal 2. No trip occurs.
- Train 2 approaches signal 1 (Figure 3)
- Route for train 2 is set (to pass by train 1) (Figure 4)
- From RBC point of view train 1 (due to minSFE) is still in front of signal 2 (Figure 4)
- The MA based on the route set for train 2 is assigned to train 1 which leads to a critical situation (Figure 4)
- (1): by passing a signal and the occupation of the section, a CES is sent to the train at a location 75m in advance. If the CES is considered, a new MA with a EoA at this signal is sent to the train (Figure 4)

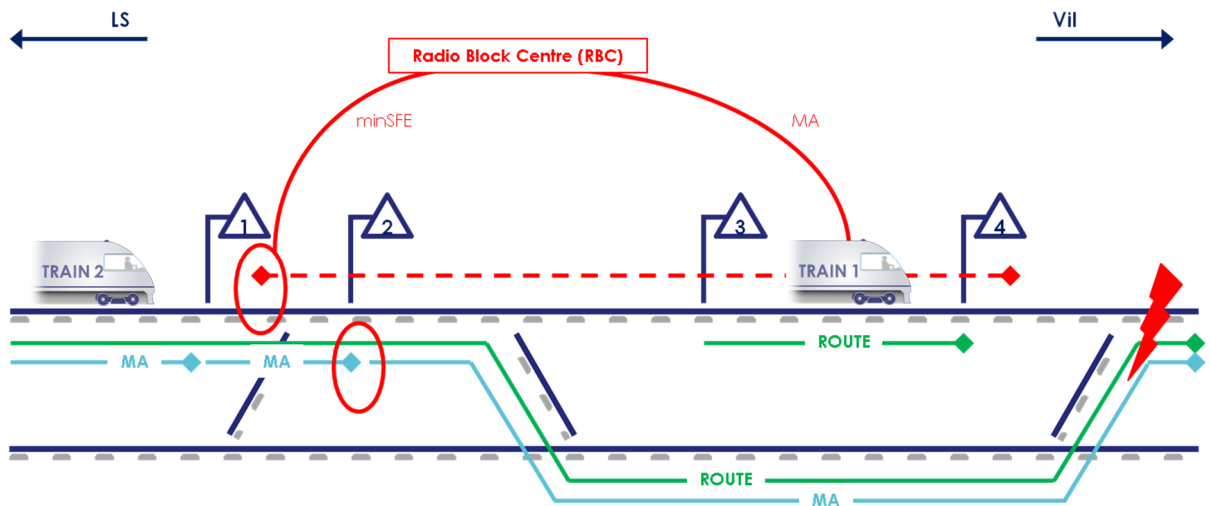
Figure 4

The above described chain lead ultimately to a reaction of the RBC to issue a MA to the train that had gathered a significant inaccuracy in its position.

This requested functionality within the RBC should monitor the confidence intervals of the various ETCS Level 2 OBS in operation in accordance with the threshold defined by the Operator. If the confidence interval of a given ETCS Level 2 OBS would exceed this threshold, the RBC should initiate an adequate reaction to maintain the overall system safety.
