TRAFIKKVERKET

# Incident on the Breda line

Preliminary report

13 September 2019

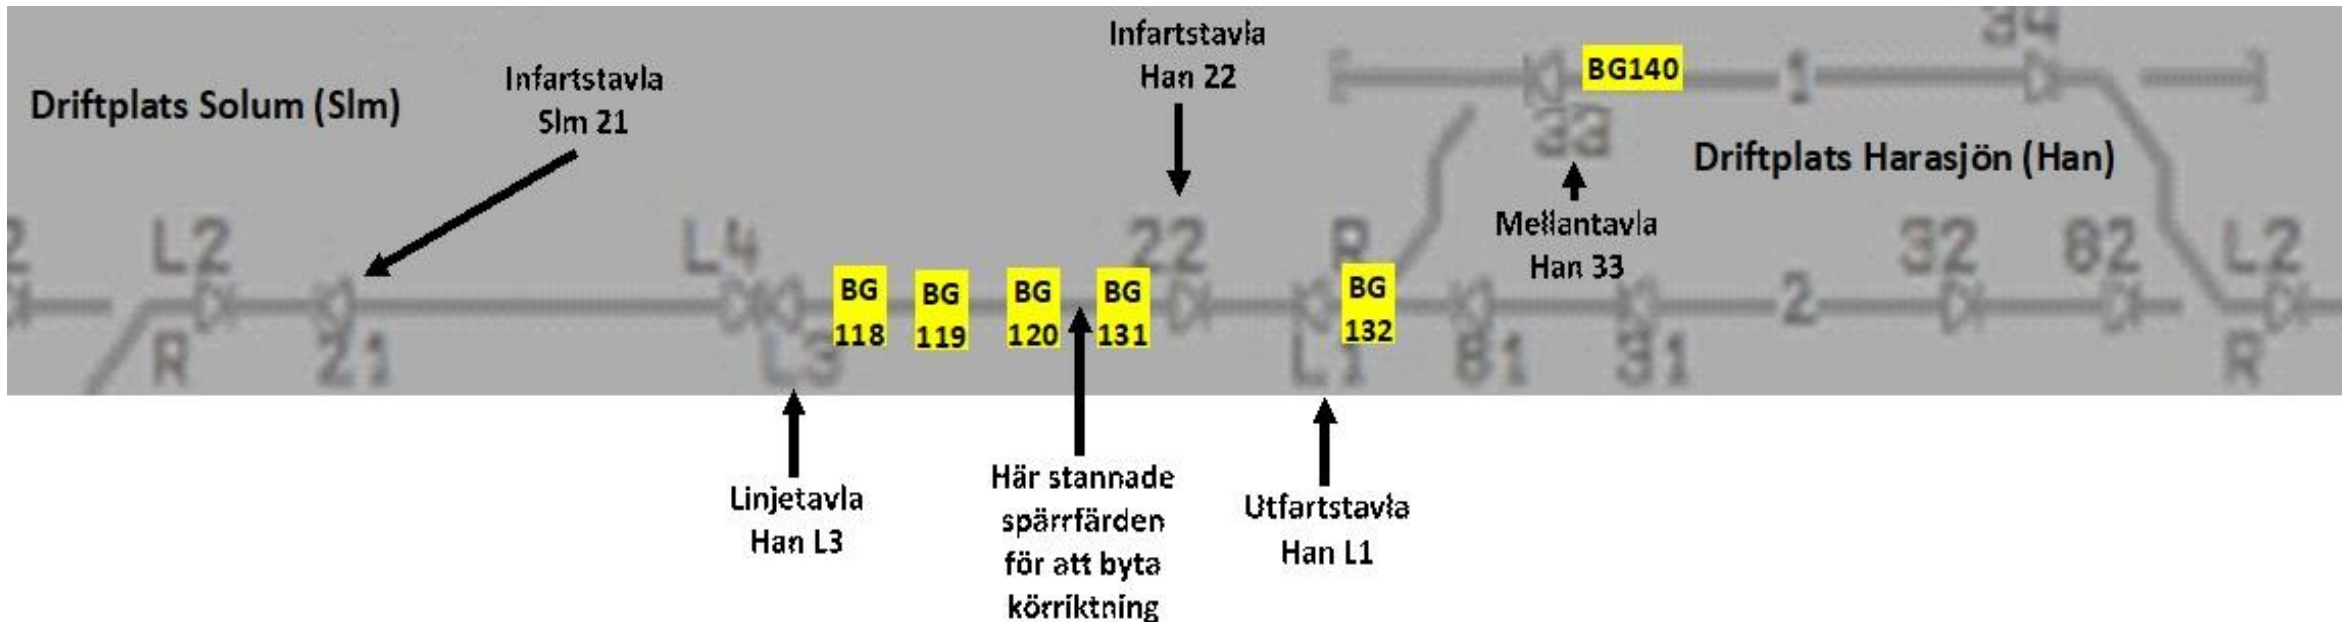
1. The maintenance vehicle started with a movement authority, operating mode "full supervision" (MA-FS) from Harasjön track 1 (intermediate board 33, balise group 140).
2. The vehicle stopped out on the line after having passed balise group 131, but before balise group 120.
3. The driver performed a "End of mission" and the MA was withdrawn.
