Safety Warning

NSA: The Netherlands

Date: 25 September 2014.

## **Wear of locking ring for cover of buffers.**

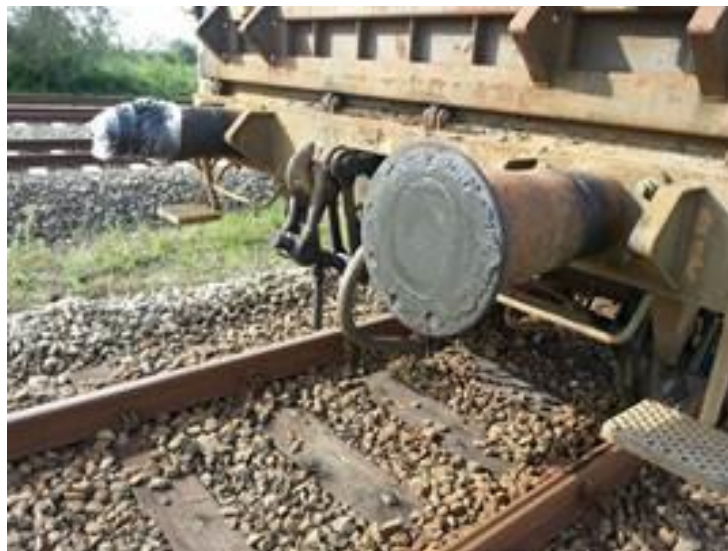
Due to wear of the locking rings in the cover of a buffer the bufferplate with the cover felt into the tracks. A following train hit the bufferplate with the cover and damaged the transponders for the signaling systems of the locomotive.

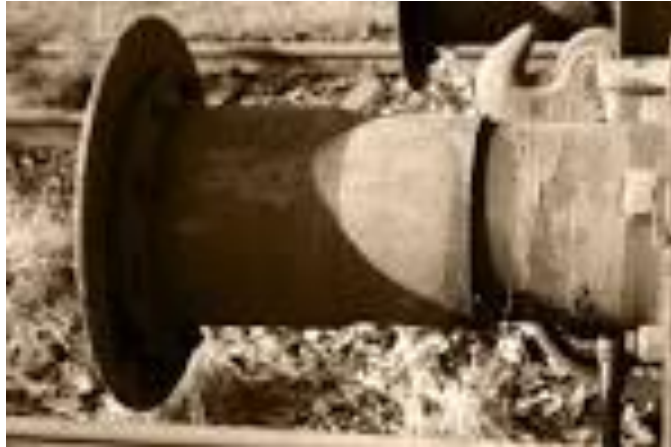
An inspection of the components of the buffer involved learned that the locking rings showed wear. The thickness as the corners of the (half) rings showed wear. Due to the wear the rings are pulled out of the savings for the rings. The difference of the diameter of the cover for the buffer plate and the cover for the buffer feet was big enough to let the locking rings pass by.

Based on the findings during the inspection a further examination of the buffer is required for buffers with a length more the 625 mm.

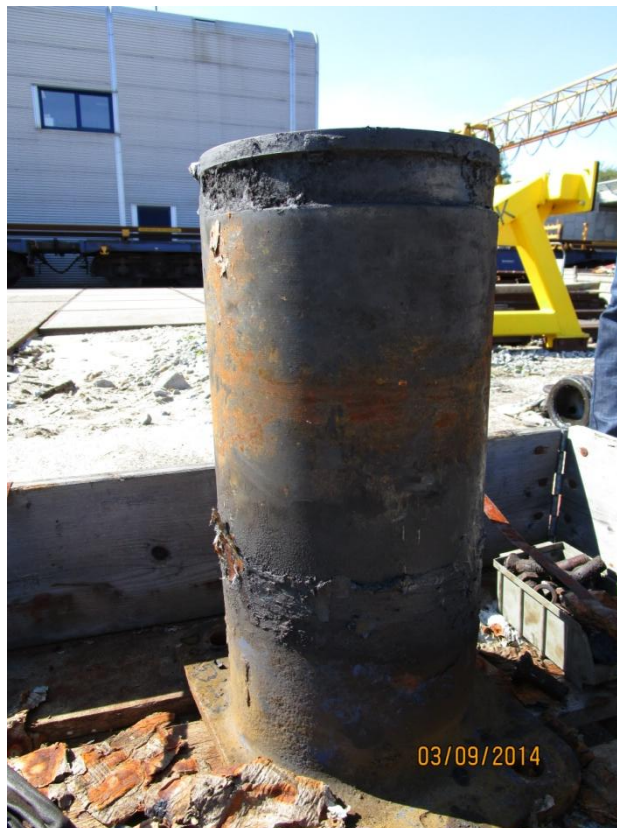
Saving of locking rings in buffer feet

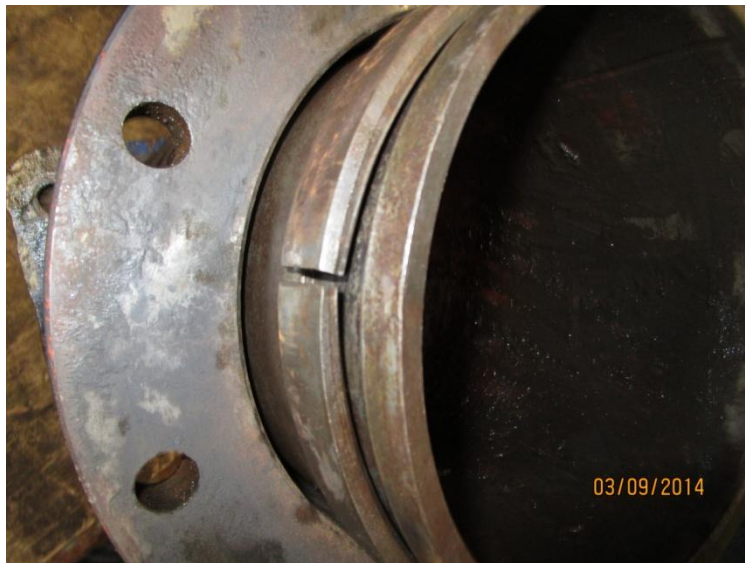
Diameter difference of locking rings and saving for locking ring

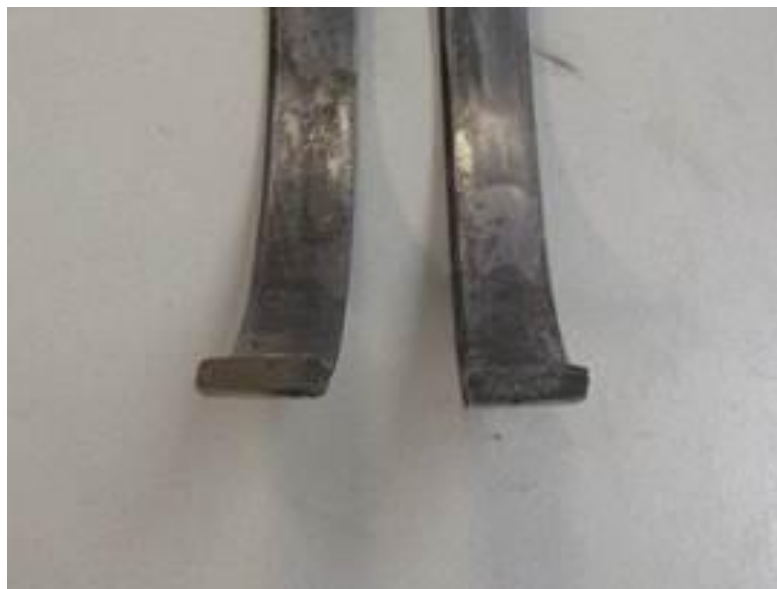
Wear of the locking ring around the load bearing corners

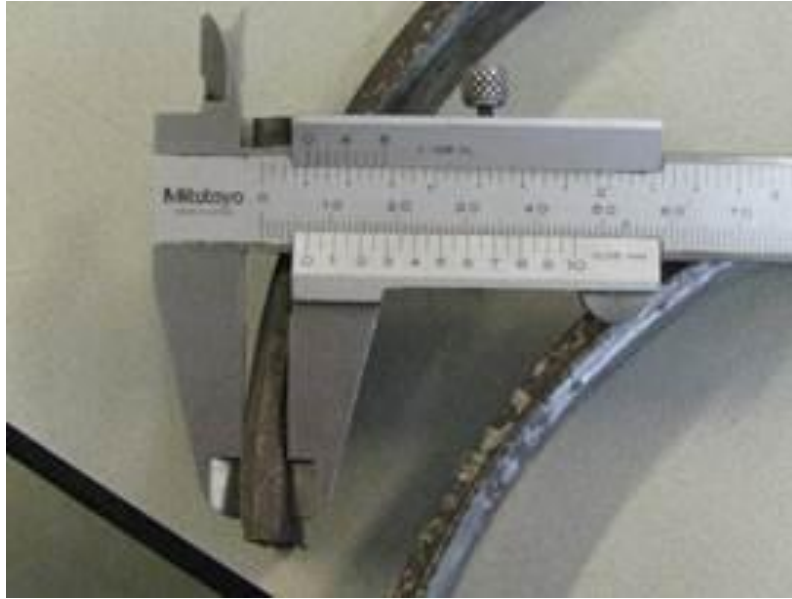
Reduced thickness of the rings.
