URGENT SAFETY ADVICE (ERA)

1. INCIDENT DESCRIPTION			
LEAD INSPECTOR	Andy Hall	CONTACT TEL. No.	01332 253306
INCIDENT REPORT No	665/02	DATE OF INCIDENT	05/06/13
INCIDENT NAME	Newcastle Central Station, Platform 10		
TYPE OF INCIDENT	Passenger trapped in train doors and dragged		
INCIDENT DESCRIPTION	<p>At about 17:00 hrs on 5 June 2013, a three-car, class 185, multiple unit was standing at platform 10 waiting to form train 1P59, the 17:02 hrs service from Newcastle to Manchester Airport. Shortly before the scheduled departure time, a passenger approached the train from the ticket office end (near field in the Figure 1), intending to board. The doors on the first (rear) coach were closed, but the rear set of doors on the middle coach was still open.</p> <p>These doors were closing as the passenger reached them, so she put her right hand between the door leaves expecting this to cause them to re-open. They did not; instead they closed around her right wrist and trapped it. The train then started to move forcing the passenger to walk and jog alongside.</p> <p>At this point, the train guard, who was leaning out of the rear cab window, could not see the trapped passenger due to the cur

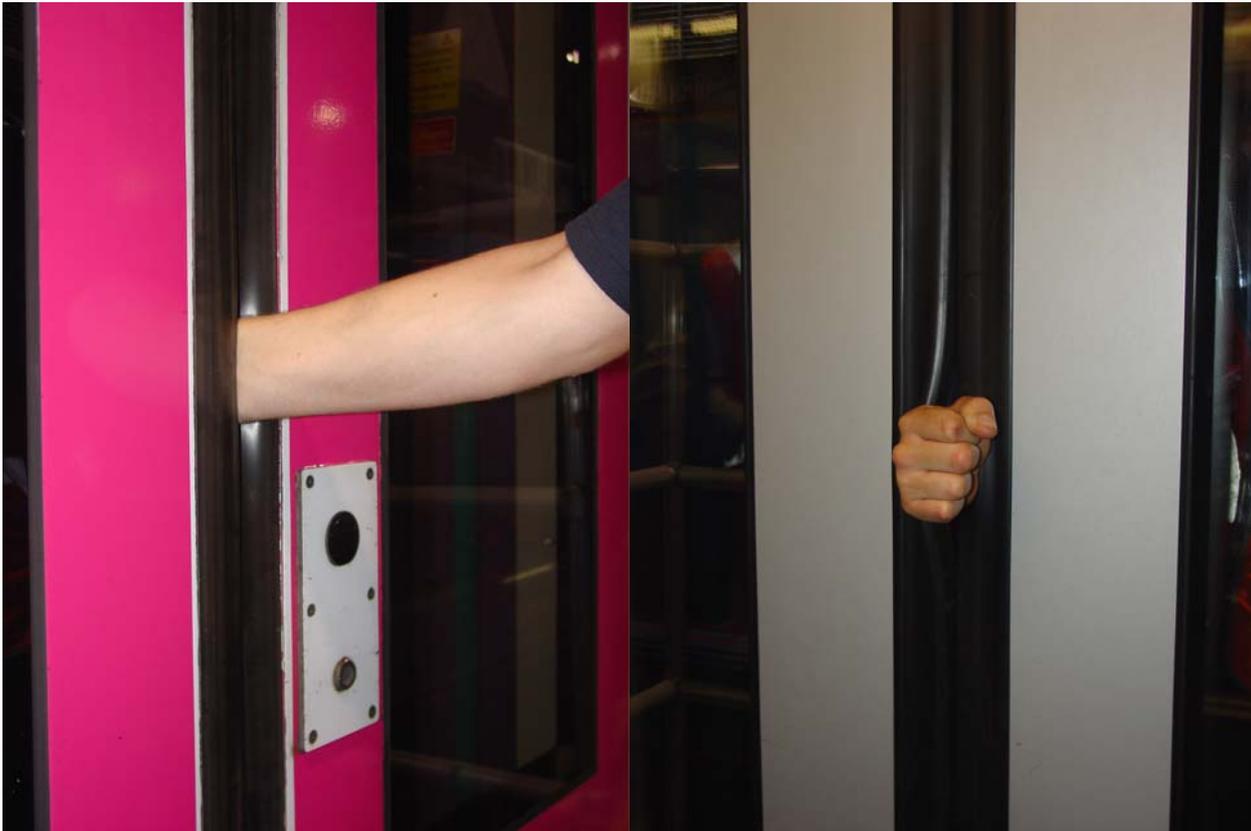
*Figure 4
door*

Adult male wrist (approximately 45 mm by 70 mm) trapped in a door detected as closed and locked

CIRCUMSTANCES:	<p>The RAIB is conducting a full investigation into the incident. As part of this investigation, the doors of the coach involved were tested with the assistance of the industry parties involved.</p> <p>Post-incident testing on the doors involved, confirmed that when a test piece specified by Railway Group Standard GM/RT 2473 (30 mm by 60 mm) was held in the doorway, long edge vertically and at a right angle to the door leaves, the obstacle detection system caused the closing doors to re-open in compliance with the Standard. The same occurred when the test is repeated with the smaller GM/RT 2473 test piece (10 mm by 50 mm) held long edge vertical and at a right angle to the door leaves. If this smaller test piece does become trapped, as explained below and allowed by the Standard, the force required to withdraw it is around 100 N.</p> <p>Further tests found that if a force is applied to the male seal at an angle to the motion of the door, the male door seal could be deflected towards the inside of the coach without compressing the associated sensitive edge, making it ineffective (see Figure 3). As the female sensitive edge is disabled before the seals fully engage, obstacles may then be trapped and not detected.</p> <p>Tests showed that this condition could be re-created with an adult wrist (see Figure 4), larger than both the wrist trapped in the incident and the test pieces specified in GM/RT 2473. The wrist is then firmly trapped and the train capable being driven away.</p> <p>Although it was not easy to re-create this condition, the actions needed to deflect the male seal were consistent with actions which might be taken by a passenger attempting to board while the doors are closing. This condition could be repeated on all 4 sets of doors on the vehicle involved in the incident.</p>

CONSEQUENCES	Risk of injury and loss of life.		
REASONS FOR ISSUE AND SAFETY ADVICE:	<p>This Urgent Safety Advice is being issued to make Manufacturers, Railway Undertakings and Entities in Charge of Maintenance of passenger vehicles with electric sensitive door edges aware of the possibility of overcoming the protection provided by a sensitive edge system by means of angular deflection of a nosing rubber. Consideration should be given to any measures, whether technological and/or procedural, necessary to manage the associated risk to a tolerable level.</p>		
USA SIGN-OFF*			
INSPECTOR NAME:	Andrew Hall	CI / DCI NAME:	Simon French (Deputy Chief Inspector)
INSPECTOR SIGNATURE:	Electronic copy	CI / DCI SIGNATURE:	Electronic copy
DATE:	23/10/13	DATE:	23/10/13
