Annex 1

Table A – vehicle EVN 33684954499-2

Images of the broken wheel of the vehicle EVN 33684954499-2

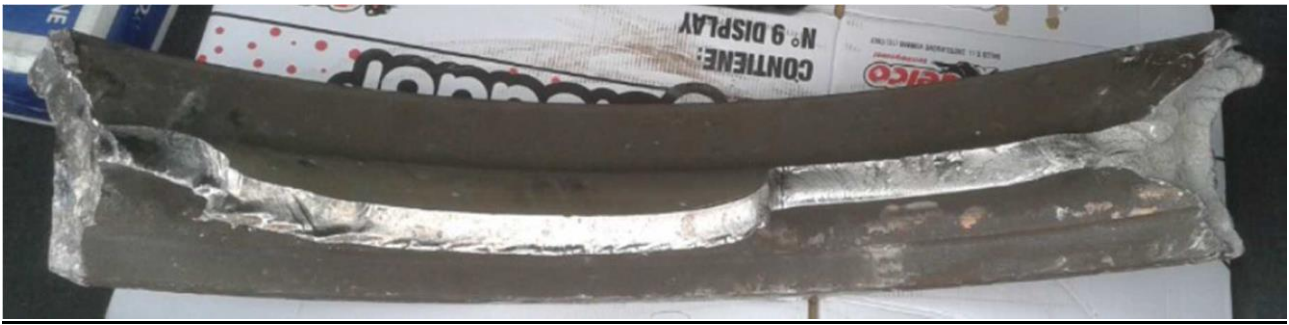
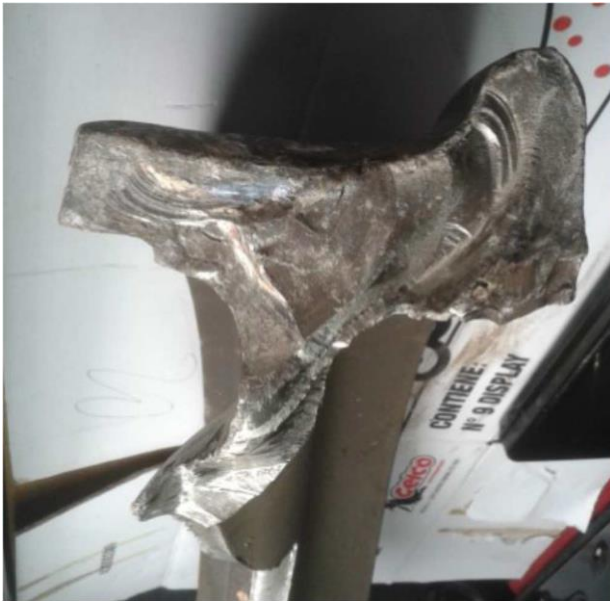
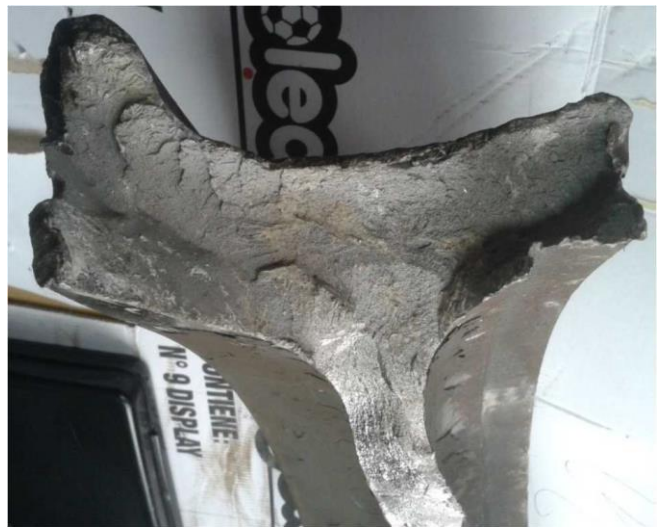
Images of fragments detached by the broken wheel of the vehicle EVN 33684954499-2

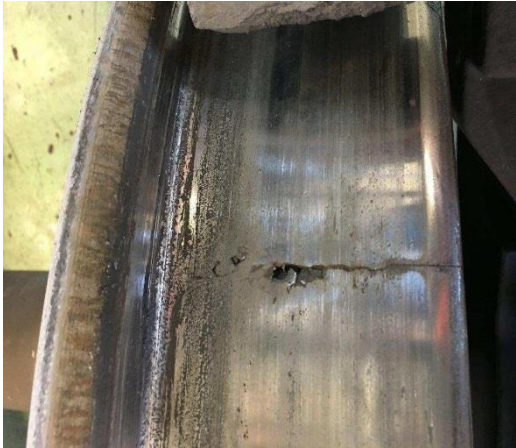
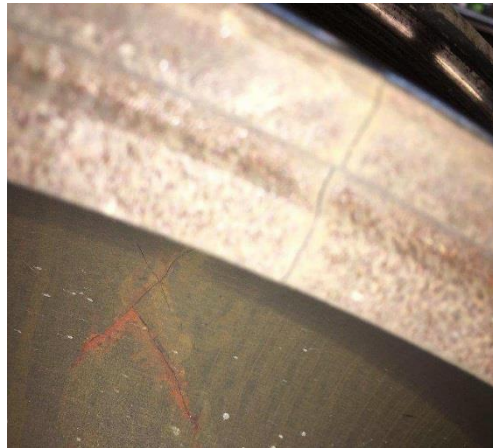
Images of the crack on the wheel of the vehicle EVN 8385 4561 015-9

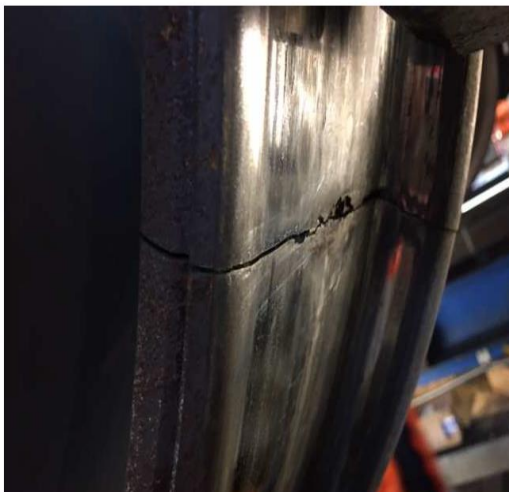
Immagine n. 3 - carro 3385 4575 322-4

Images of the crack on the wheel of the vehicle EVN 33854575322-4
