Rail Accident Report

Freight train derailment at Ely West Junction 14 August 2017

Report 09/2018
August 2018

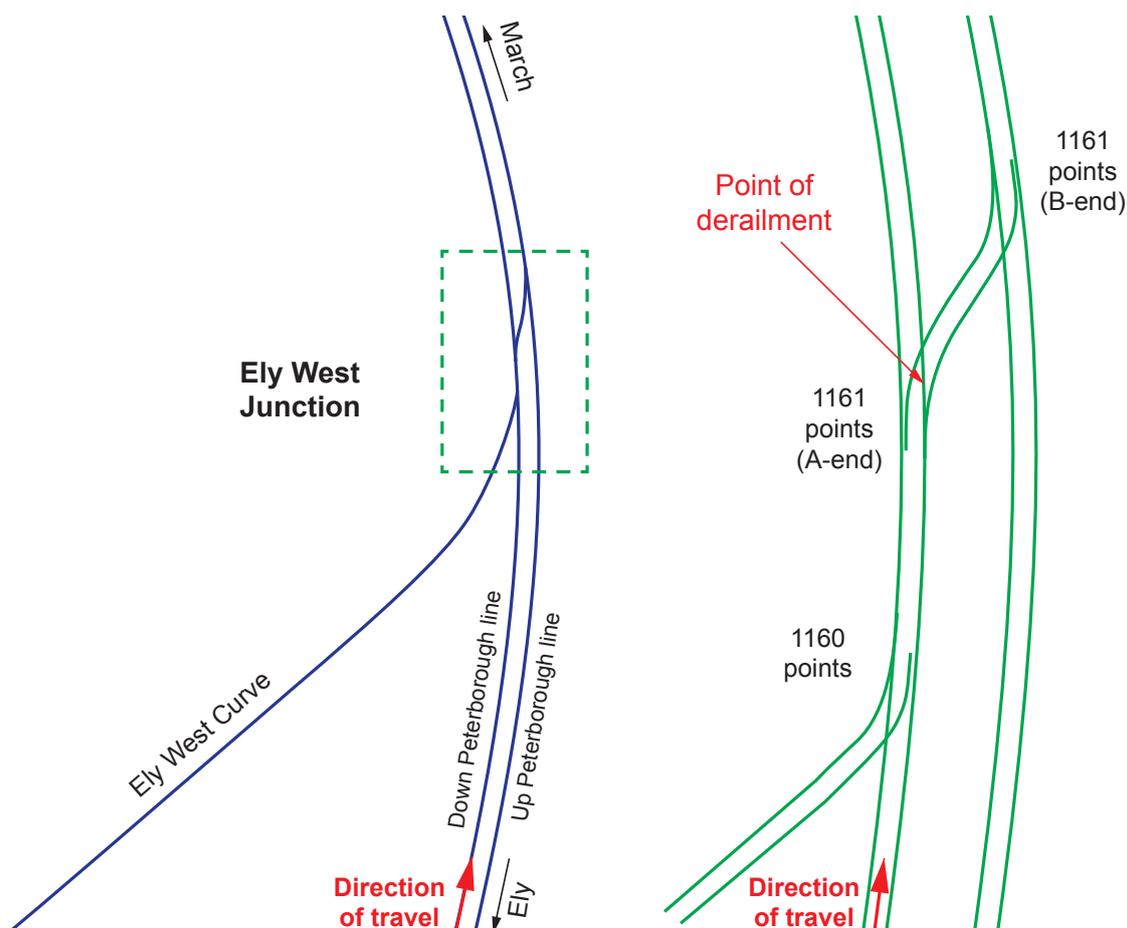
Figure 3: Track layout at Ely West Junction

- 7 The derailment took place on the plain line between the toe of 1161A points and its crossing nose (located 43 metres beyond the toe). The first visible derailment marks on the railhead were approximately 24 metres after the toe (figure 3).

- 24 At 14:21 hrs, locomotive 66713 passed over 1161A points at Ely West Junction. Shortly afterwards, when the leading right-hand wheel of wagon 630034 was 24 metres beyond the toe of 1161A points, it climbed onto the railhead and travelled along it for about 12 metres before dropping into the six-foot⁴ (figure 3).

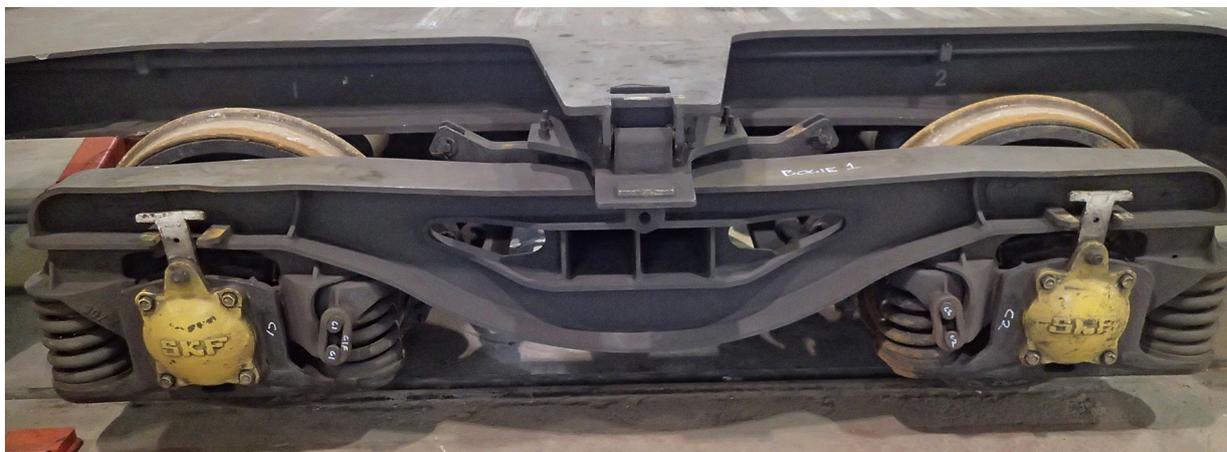
Figure 6: Y33 bogie (leading bogie on wagon 630034)

- 19 The bogies fitted to the FEA-A wagons were Y33 bogies (figure 6). They are a derivative of the Y-series family of bogies, widely used across the UK and in Europe for the past 50 years.

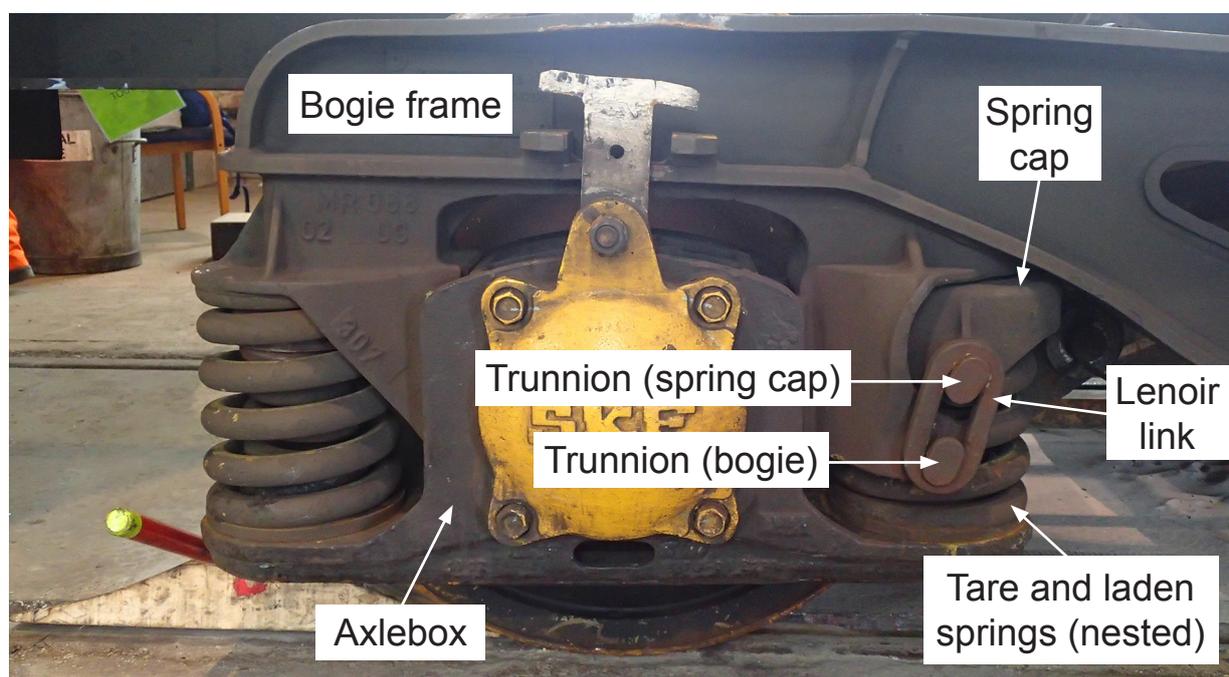
Figure 7: Components of damping system on Y33 bogies

28 Almost all road and rail vehicles incorporate some damping to minimise the amount of bouncing they experience following external inputs, eg unevenness in the road or track. Y33 bogies use a friction-damping arrangement where the vertical movement of the axlebox within the bogie frame horn guides is damped by friction. The key components of the damping arrangements are the Lenoir links, the spring cap and its wear plate, the plunger and the axlebox. Figures 7 and 8 show how these individual components are arranged.

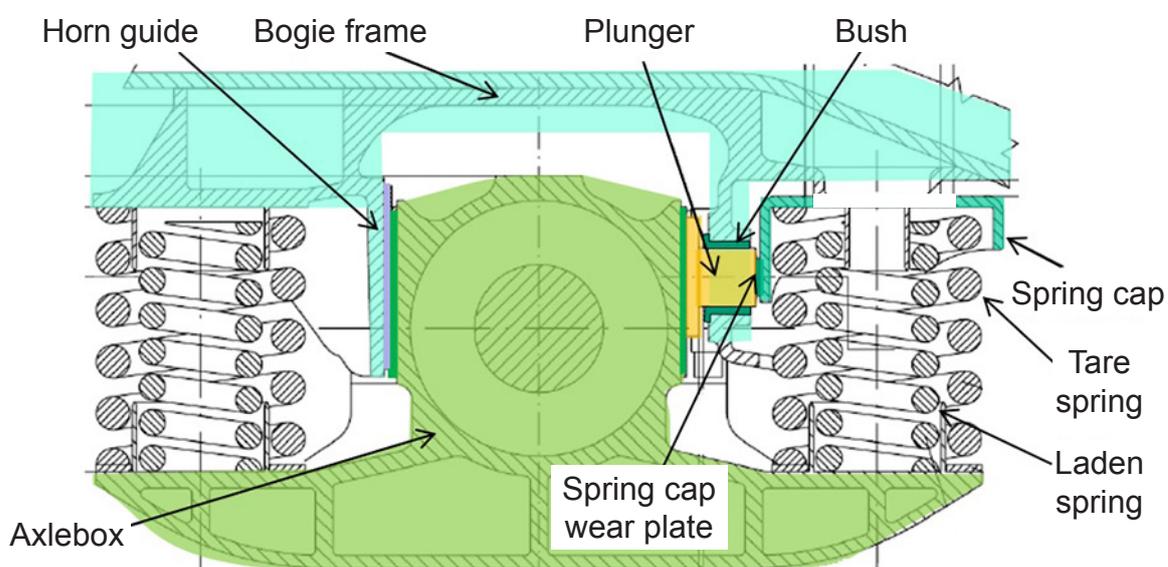
Figure 8: Components of damping system on Y33 bogies

- 30 Under the horizontal component of the load in the links, the spring cap wear plate pushes against the plunger which is free to move inside a bush (figure 8). The plunger pushes against the axlebox which in turn pushes against the bogie frame horn guide wear plate. If the axlebox slides up or down inside the horn guides, the axlebox has to overcome the frictional force provided by the horizontal load which pushes the components against one another, hence the name 'friction-damping'.

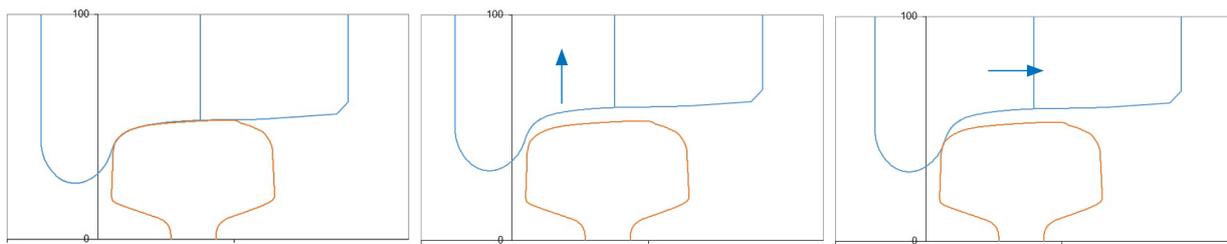
Figure 12: Wheel in contact with rail – normal condition (left), wheel in flight (middle), wheel landing in partially climbed state (right)

44 This simulation predicted that the leading right-hand wheel of wagon 630034 would fully unload at the point of derailment¹⁰. The leading right-hand wheel was predicted to lose contact with the railhead and to rise 6 mm (described as wheel flight) before re-contacting the rail in a partially climbed state (figure 12). At that point, the ratio of lateral load to vertical load applied to the wheel was also predicted to be high enough to continue to promote a derailment.

45 The level of partial climb predicted in the simulation (approximately 6 mm) is at a position at which the contact angle between the wheel flange and the rail starts to reduce. If the ratio of lateral load to vertical load is unfavourable, as was the case in the simulation¹¹, the wheel will likely continue to climb and eventually lead to a derailment. The RAIB therefore concluded that the simulation predicted a high risk of derailment at the point at which the leading right-hand wheel actually derailed.
